***PERFORMANCE ANALYSIS
ASTERRA SATELLITE LEAK DETECTION SERVICES***

Pine-Strawberry
Water Improvement District, AZ
November 2022

Executive Summary Report

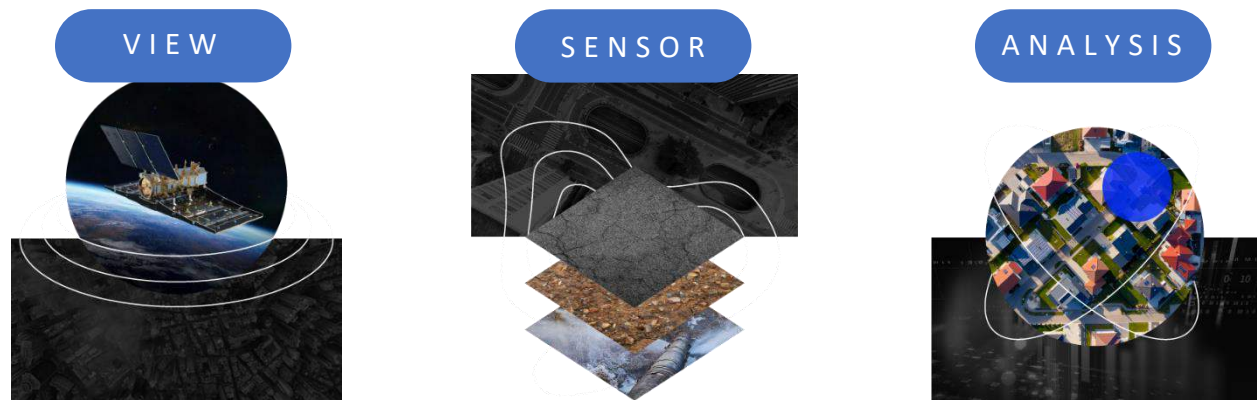
ASTERRA utilizes specialized radar signals taken from a satellite to scan the area of interest and collect the resulting reflected signals. These signals are analyzed and processed to identify specific indicators of wet soil saturated with potable water, screening out the signal noise and other interferences. The result is a map showing points of interest. The ASTERRA analysis typically highlights 5-10% of the entire system length, and only these locations, where there is expected to be a leak, are inspected by BOTG leak detection teams. Thus, the time and resource cost of leak detection is much lower than traditional leak detection approaches (e.g., full-system, random, systematic, or block map).
