Geotechnical Investigation Report

***Pine Strawberry Water Improvement District
SV3 Waterline Improvements
Approximately 2,300 LF (0.44 miles) of Water Transmission Line
Near the Intersection of AZ-87/AZ-260 and FR708
Strawberry, Arizona 85544***

Project 33392

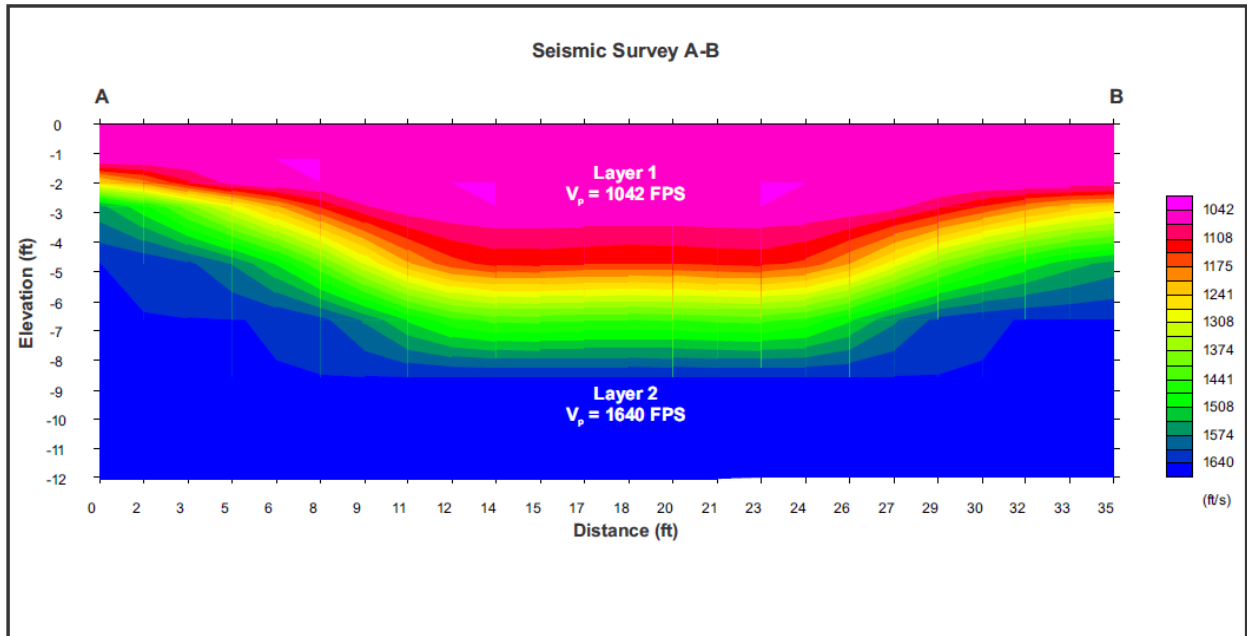
Figure 7: Tomographic Cross Section of Seismic Survey Line A-B

Line	Layer 1			Layer 2		
	Velocity	Depth (ft)		Velocity	Depth (ft)	
A - B	1042	-	-	1640	2.2	6.2
C - D	1029	-	-	2075	2.9	6.5
E - F	975	-	-	2090	2.2	6.3
G - H	873	-	-	1626	1.5	3.1
TB-1	-	-	-	-	-	5.0
TB-2	-	-	-	-	-	5.0
TB-3	-	-	-	-	-	3.0
TB-4	-	-	-	-	-	1.5
TB-5	-	-	-	-	-	1.5
Averages	980	-		1858	3.6

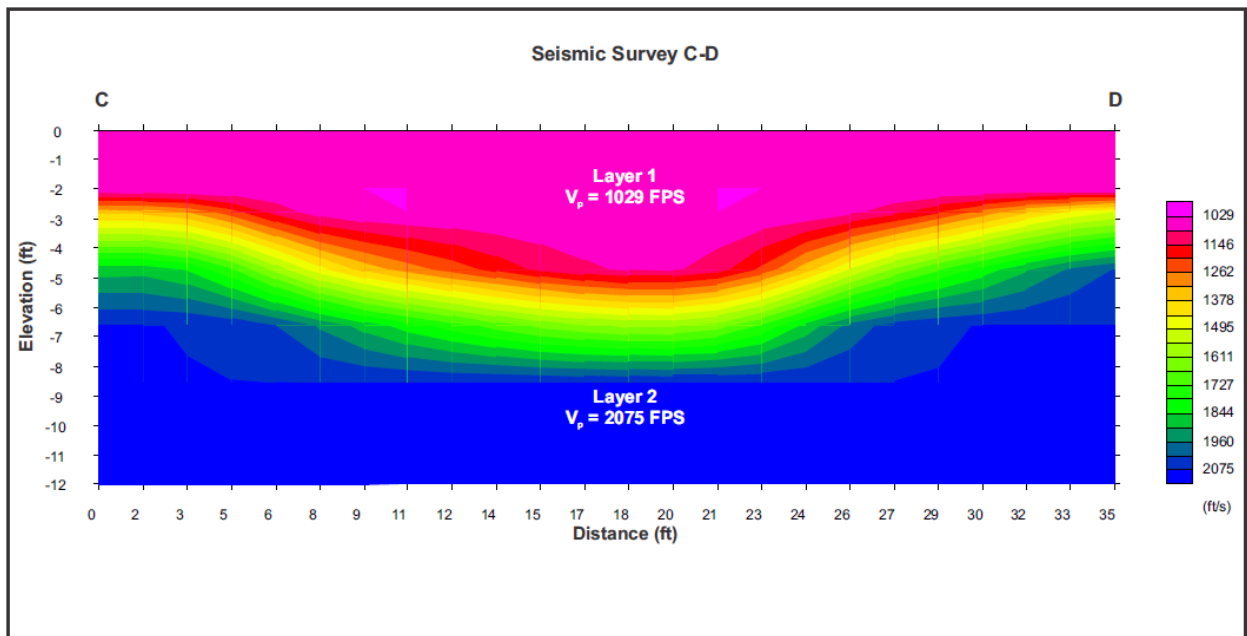
Figure 8: Tomographic Cross Section of Seismic Survey Line C-D

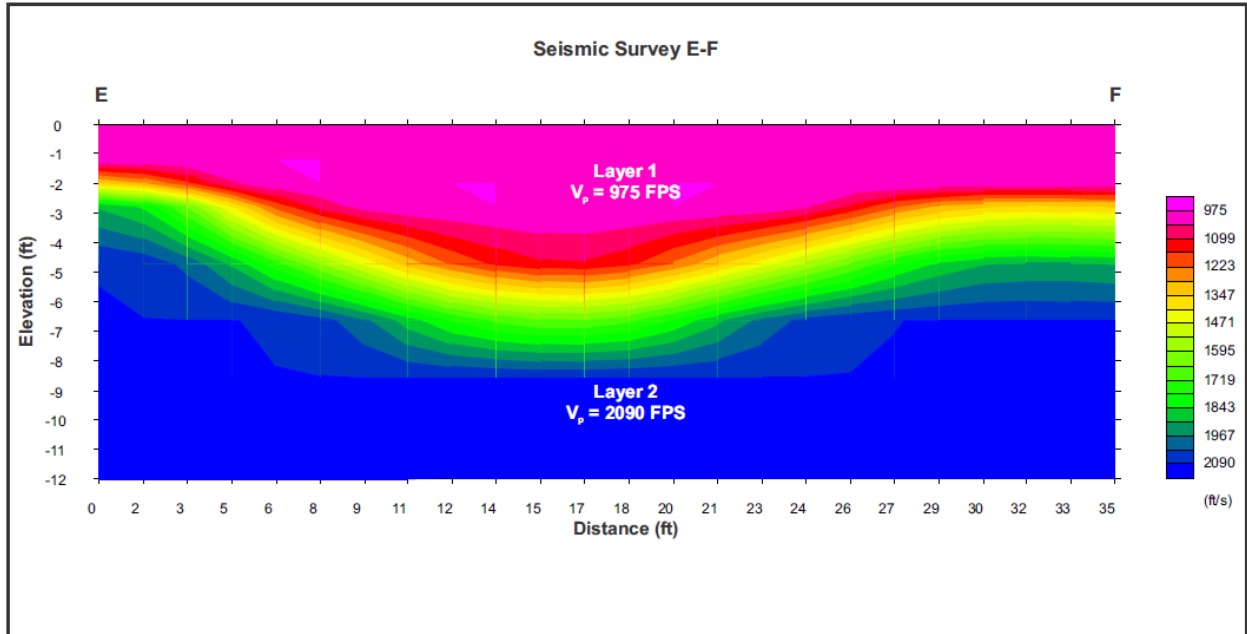
Figure 9: Tomographic Cross Section of Seismic Survey Line E-F

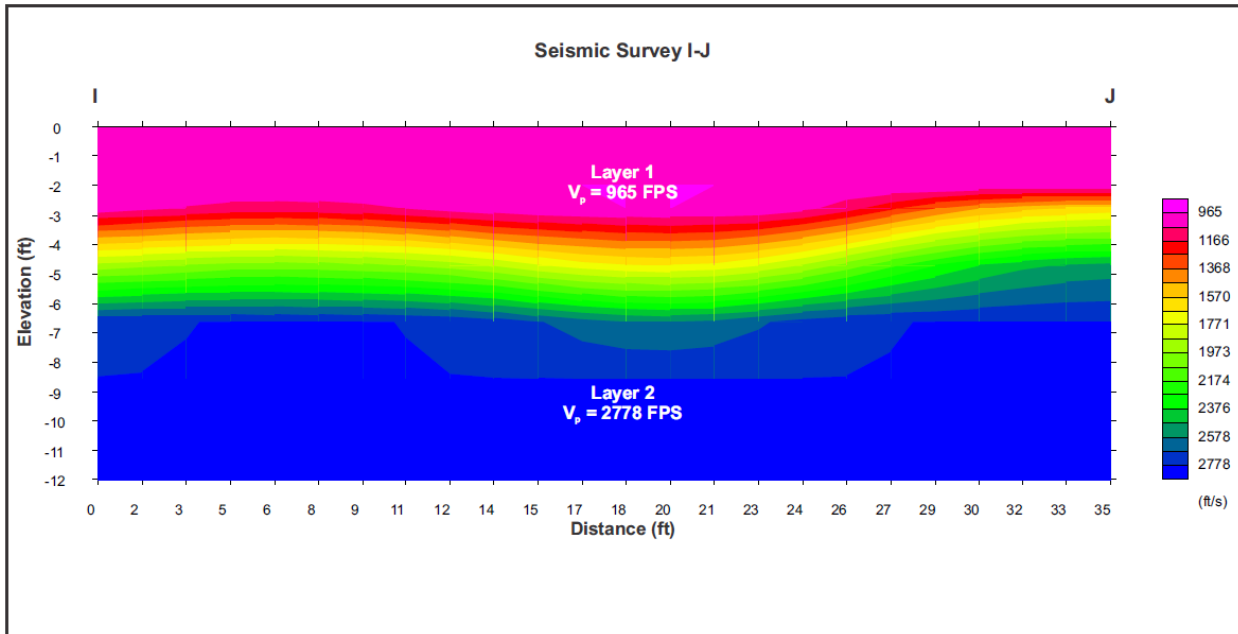
Figure 11: Tomographic Cross Section of Seismic Survey Line I-J

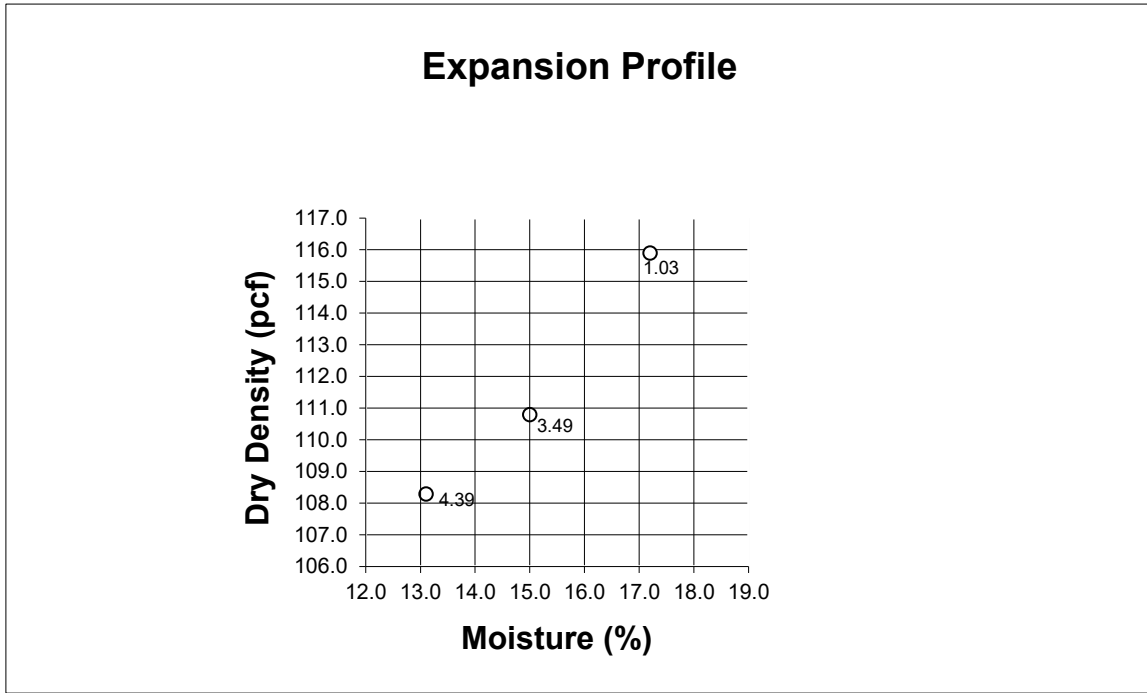
<i>Sample Location</i>	<i>Remolded Moisture Content (%)</i>	<i>Dry Density (PCF)</i>	<i>Volume Change After Saturation (%)</i>	<i>Adjusted Volume Change After Saturation (%)</i>
TB-4 (4.0'-5.0')	17.2	115.9	1.13	1.03
TB-4 (4.0'-5.0')	15.0	110.8	3.83	3.49
TB-4 (4.0'-5.0')	13.1	108.3	4.82	4.39
Percent #4 Retained		9
